Manhole Inspection Summary

Manhole # S13Q__028MH

Insp Date: **3/17/08 12:07 PM**

Location Address: **510 Hurley Ave**

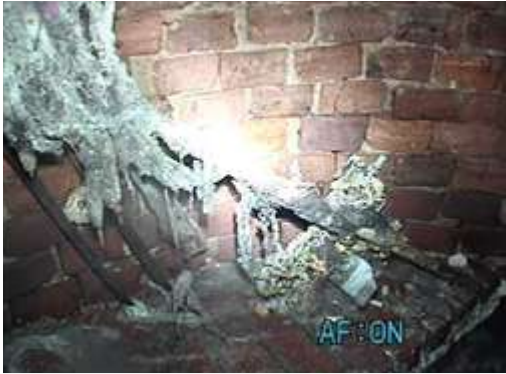
Defect 7

Condition: ☐ Sound ☒ **Cracked** ☐ Root Intrusion ☒ **Loose Brick** ☐ Deteriorated

cracks in barrel

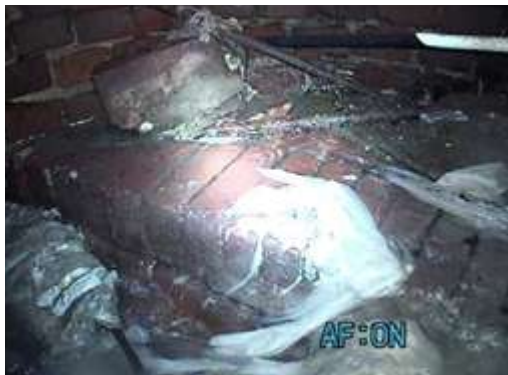
Defect 6

Condition: ☐ Sound ☐ Cracked ☐ Root Intrusion ☐ Deteriorated ☐ Leaks ☒ **Debris**

Bench debris

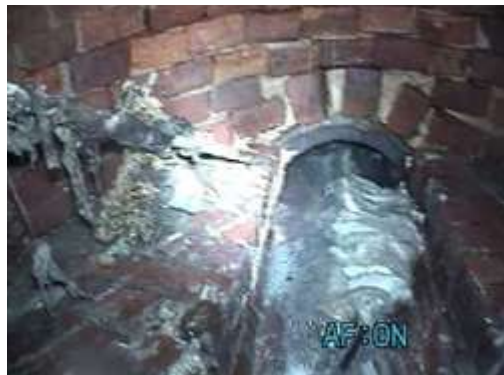
Defect 5

Condition: ☐ Sound ☐ Cracked ☐ Root Intrusion ☐ Deteriorated ☐ Leaks ☒ **Debris**

channel cond debris

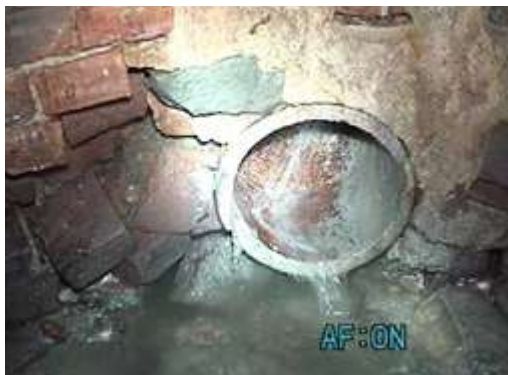
Defect 3

loose bricks in barrel

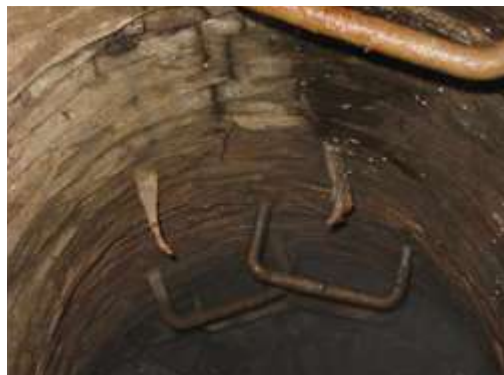
Defect 1

Count: **7** Missing: **1** ☒ **Corroded**

steps corroded/missing

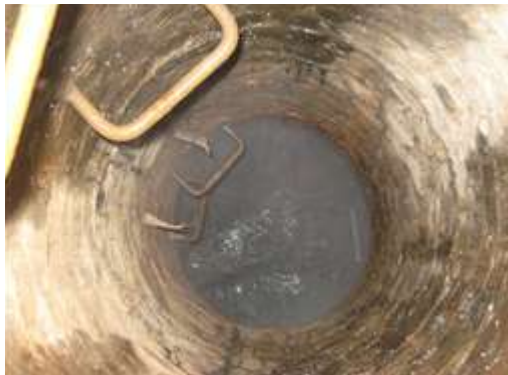
Defect 4

Infiltration: ☐ None ☐ Joint ☐ Cracks ☐ Mortar ☐ Roots ☒ **Wall**

signs of barrel & corbel infiltration in wall

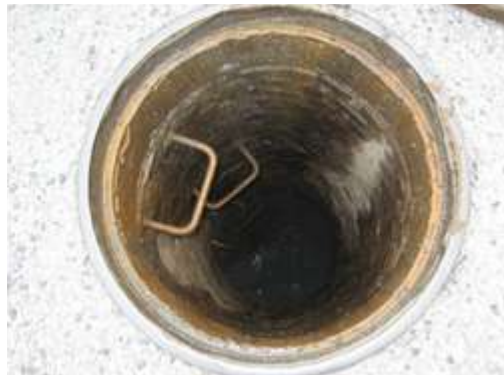
Defect 2

Condition: ☐ Sound ☐ Cracked ☒ **Leaks**

Frame leaks

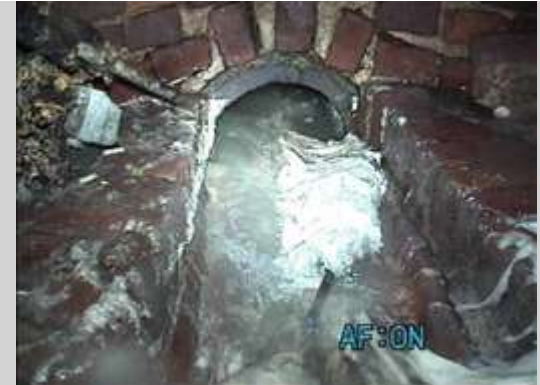
12 O'Clock Outflow

Pipe Height: **7.2** (in.) Rod and Bar (Angled)
Pipe Material: **Clay** ☐ Pipe Lined
Invert Depth: **16.02** (ft.) Flow Characteristics: **Fast**
Deposits: ☒ None ☐ Mud ☐ Sludge ☐ Debris ☐ Grease
Silt Depth: **0** (in.) Deposits Extent:
Infiltration: **None** Pipe Seal Cond: **Sound**

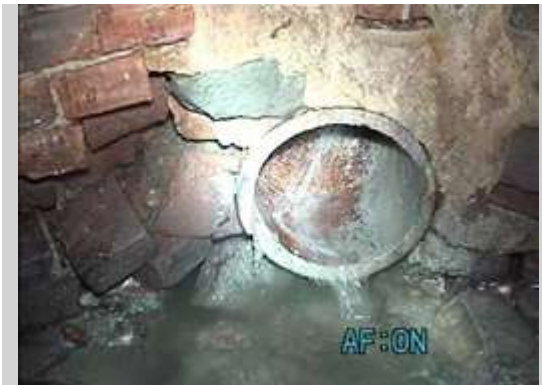
6 O'Clock Inflow

Pipe Height: **18** (in.) Rod and Bar (Angled)
Pipe Material: **Clay** ☐ Pipe Lined
Invert Depth: **15.50** (ft.) Flow Characteristics: **Slow**
Deposits: ☒ None ☐ Mud ☐ Sludge ☐ Debris ☐ Grease
Silt Depth: **0** (in.) Deposits Extent:
Infiltration: **None** Pipe Seal Cond: **Sound**

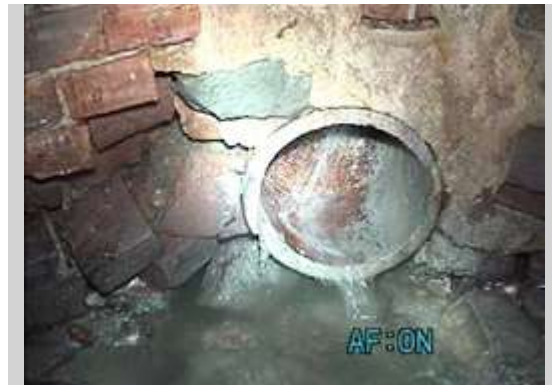
Defect 3

loose bricks in barrel

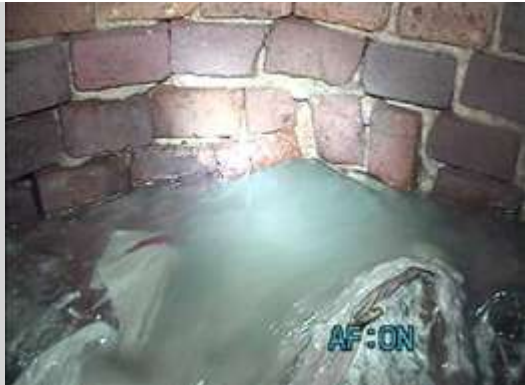
9 O'Clock Inflow

Pipe Height: **18** (in.) Rod and Bar (Angled)

Pipe Material: **Clay** ☐ Pipe Lined

Invert Depth: **15.50** (ft.) Flow Characteristics: **Fast**

Deposits: ☒ None ☐ Mud ☐ Sludge ☐ Debris ☐ Grease

Infiltration: **None** Pipe Seal Cond: **Sound**
